## **Docket No. 217 – Development and Management Plan Inspection**

Northeast Utilities Service Company Certificate of Environmental Compatibility and Public Need for the construction of a 345-kV electric transmission line and reconstruction of an existing 115-kV electric transmission line between Connecticut Light and Power Company's Plumtree Substation in Bethel, through the towns of Redding, Weston, and Wilton, and to the Norwalk Substation in Norwalk, Connecticut.

Date:	December 30, 2005

Location: 345kV XLPE Component

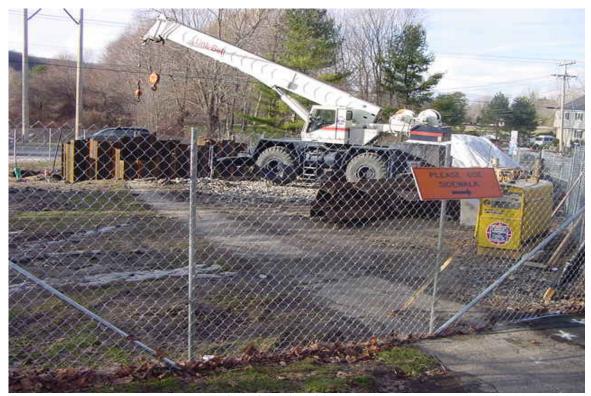
345kV XLPE (Jack and Bore): Overall view of the site with excavation underway and continued work on the bore pit. Little additional activity has occurred here due to the holidays. Snow cover has since melted. 12/30/05

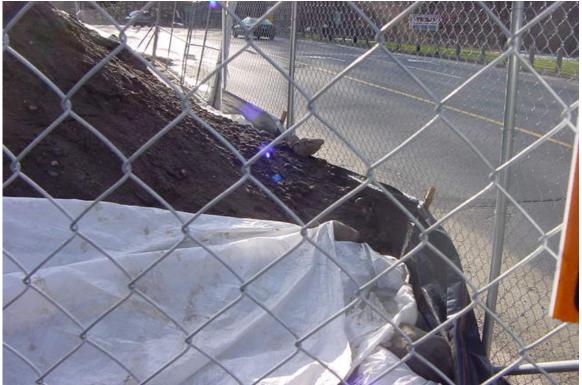
The stockpile is partially covered with plastic to reduce run-off but the silt fence needs some maintenance. If it cannot be toed-in, haybales or a berm should be installed. 12/30/05
